○ OKANOGAN-WENATCHEE NATIONAL FOREST | ○ JULY 2012

Flood Repair *projects*

PROPOSED ACTIONS FOR THE NACHES AND CLE ELUM RANGER DISTRICTS 2013 FLOOD REPAIR PROJECTS

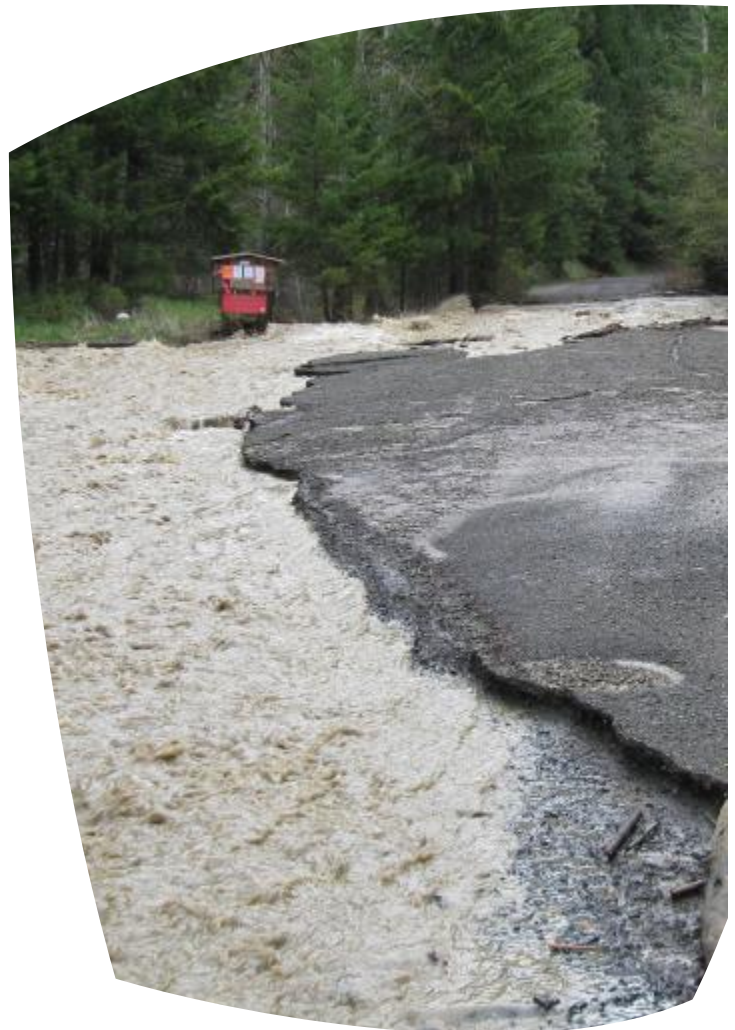
Is this a road or a stream? This is FSR 1708 in May 2011. In some places, the stream completely overtook the road.

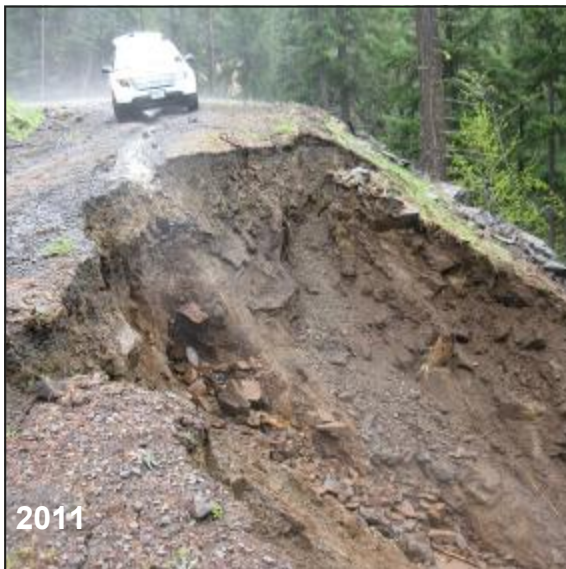
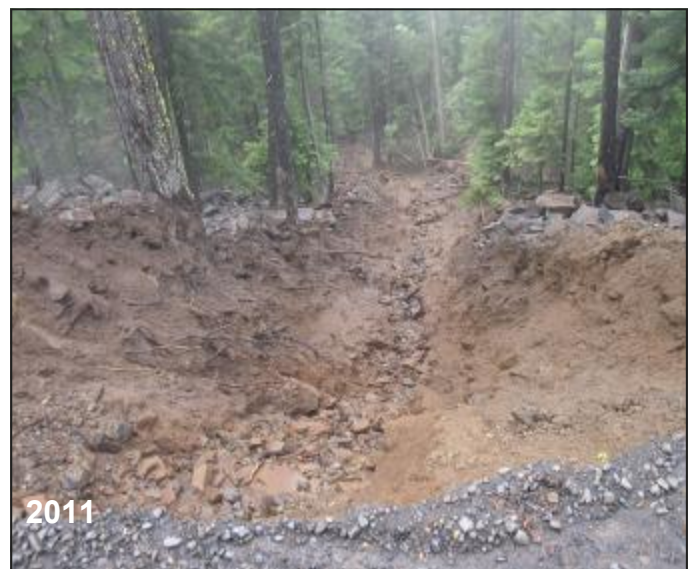
Mile Post 6.9

During the May 2011 flood, flood water caused the road fill and slope to fail as it ran down and crossed the roadway. When the road began to erode, it caused a debris flow down the side of the slope. Approximately half of the existing road prism is missing at this location. The damaged area spans 46 feet.

Option A: Repair the road in place. Excavate the existing shoulder slump area and install a 50 foot long wall with rock backfill upslope of the road. Re-vegetate the eroded slope and rebuild the aggregate road surface.

Option B: Close the road at the current junction with FSR 1916. Stabilize the slope to prevent further damage and sedimentation. This site is also in a potential restoration project area and the outcome of the road in its entirety will be analyzed in the future.

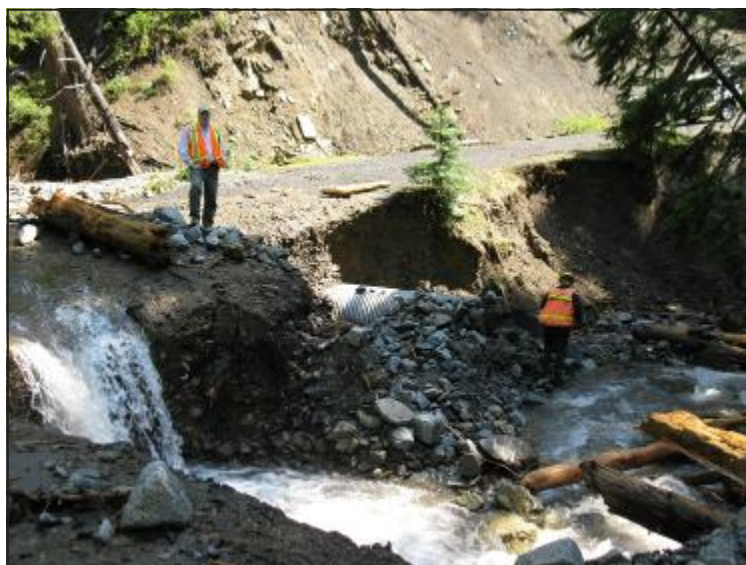
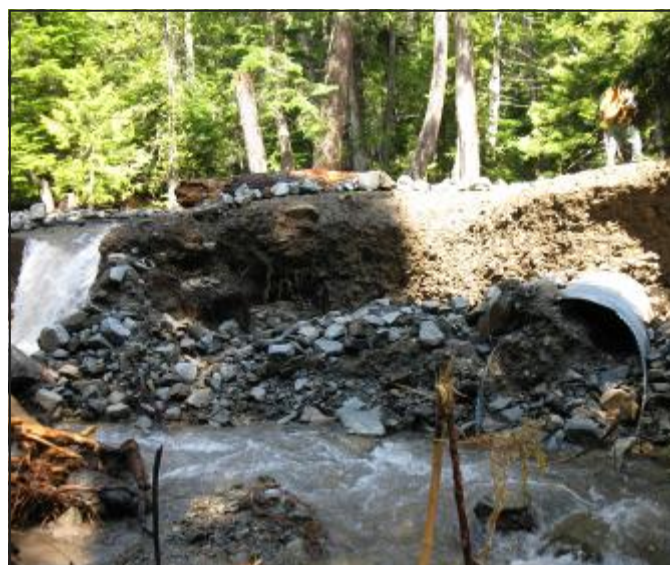
Mile Post 7.2

During the 2011 flood event, the existing 60 inch culvert failed to properly transport water below the road. The stream deposited streambed material upstream of the crossing and into the culvert. With the stream flowing over the road, a large amount of roadway and road fill washed away.

Option A: The crossing will be fixed and the road would be repaired to pre-existing single lane width.

Option B: Close the road at the junction with FSR 1916. Remove roadway and road fill that could continue to put sediment into the stream. Remove the culvert and stabilize the roadway away from the crossing.

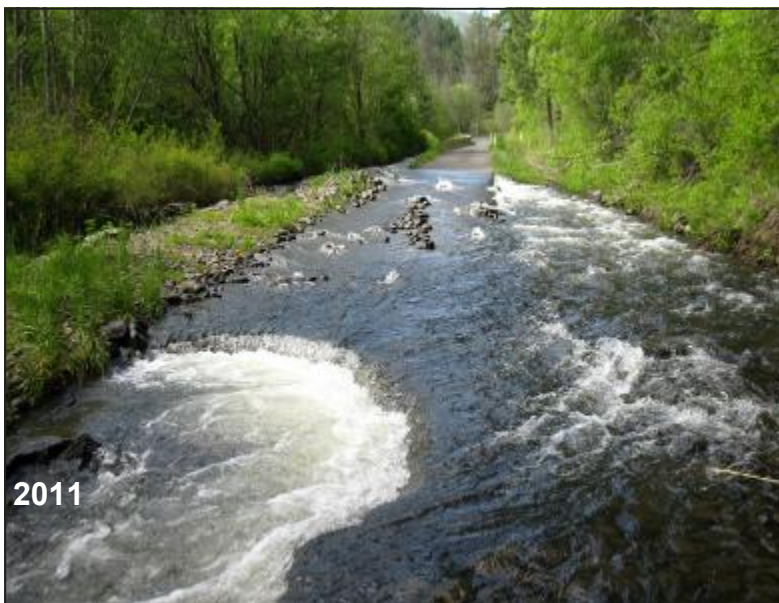
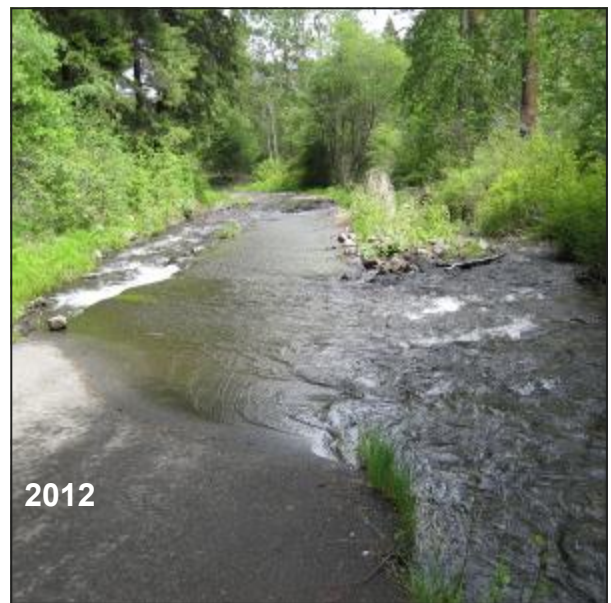
Mile Post 0.5

Damage at this location occurred in 2009 and during the 2011 flood event. The stream began flowing into the road ditch and then across the road. From mile post 0.5 for 350 feet, the stream is now running across and on the road, eroding some of the asphalt pavement surface as well as the aggregate road base. From 350 to 800 feet beyond mile post 0.5, the stream is occupying and eroding the roadside ditch. It is continually eroding the road prism pavement, and road fill along the shoulder.

Option A: Shift the roadway up and away from the channel at this location. Obliterate the old road section and restore a flood plain area with vegetation. The new road piece would be armored with rocks and large pieces of wood.

Option B: Decommission FSR 1501 from mile post 0.0 to 5.1. This would include obliterating the road, removing necessary road fill and asphalt that could wash out into the stream, and creating wood and rock structures to stabilize the area.

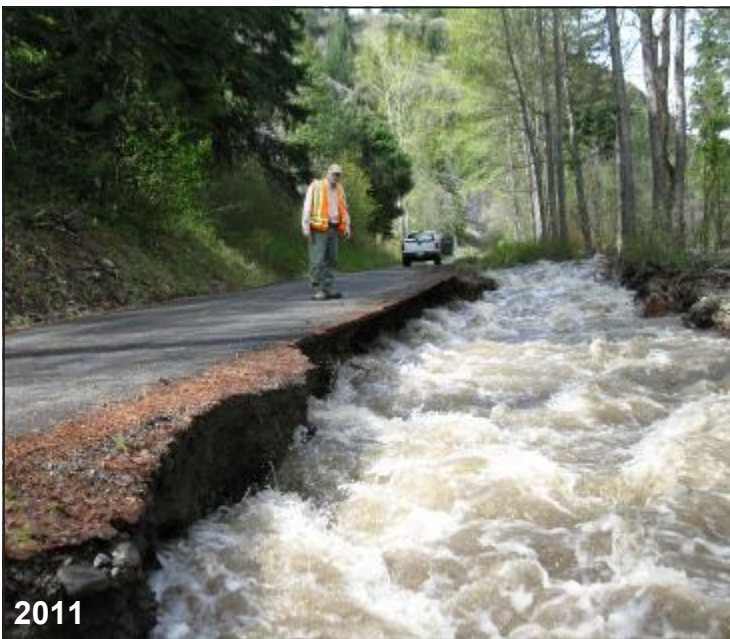
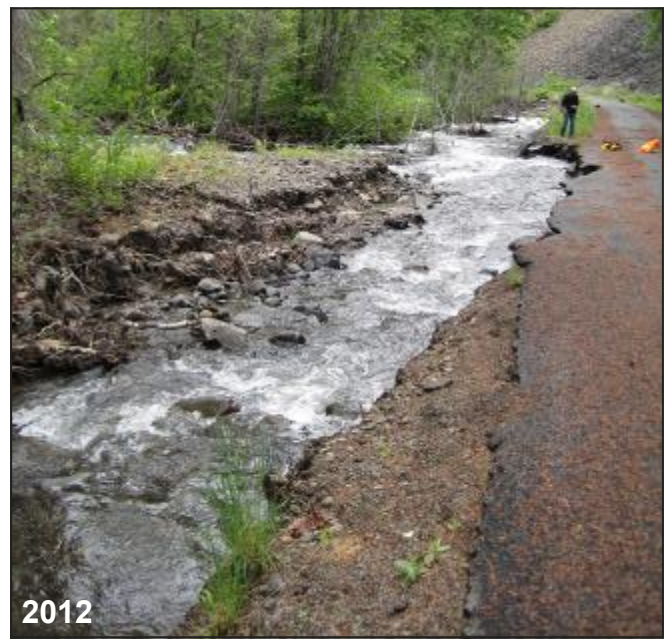
Mile Post 2.0

During a high water event, the Little Rattlesnake stream activated a side channel that cut into the road prism and eroded approximately three feet of road surface. The damage to the road surface extends 26 feet and damage to the road embankment spans a total of 74 feet.

Option A: Shift approximately 200 feet of roadway up and away from the channel. Remove the old road bed and restore a flood plain area with vegetation. The new road would be armored with rocks and large pieces of wood for stabilization.

Option B: Decommission FSR 1501 from mile post 0.0 to 5.1. This would include obliterating the road, removing necessary road fill and asphalt that could wash out into the stream, and creating wood and rock structures to stabilize the area.

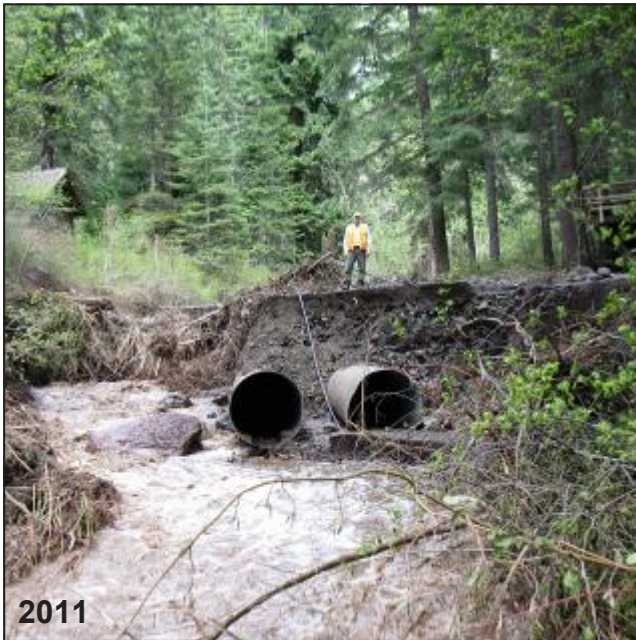
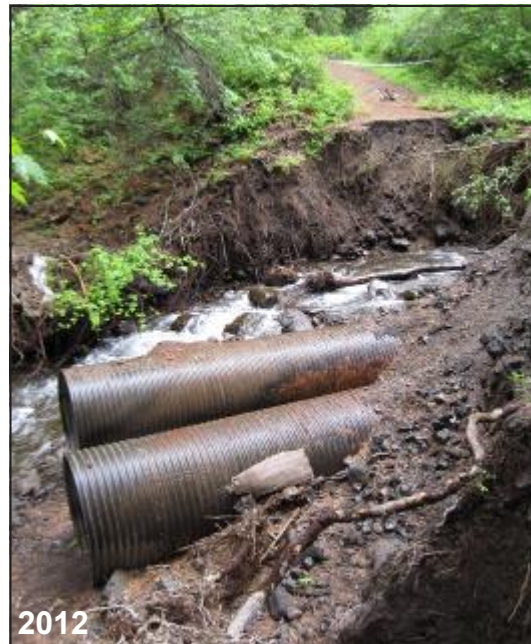
Mile Post 0.1

In the 2011 flood, Gold Creek washed out a 30 foot wide section of the road at the location of two 48 inch culverts. The culverts did not fill with debris but were unable to handle the large amount of water flowing through. A significant amount of road, road fill, and road shoulder was washed downstream. There are summer homes on both sides of the washout and both tracts can be accessed by State Highway 410.

Option A: Install an open bottom arch of approximately 15 feet in length to replace the two failed culverts.

Remove the two culverts, install arch, reconstruct the road, and re-vegetate exposed soil around the area.

Option B: Close the road at the crossing and remove approximately 100 feet of the road centered on the stream crossing. After removing the road and road fill, the stream bank would be stabilized and re-vegetated to prevent erosion.

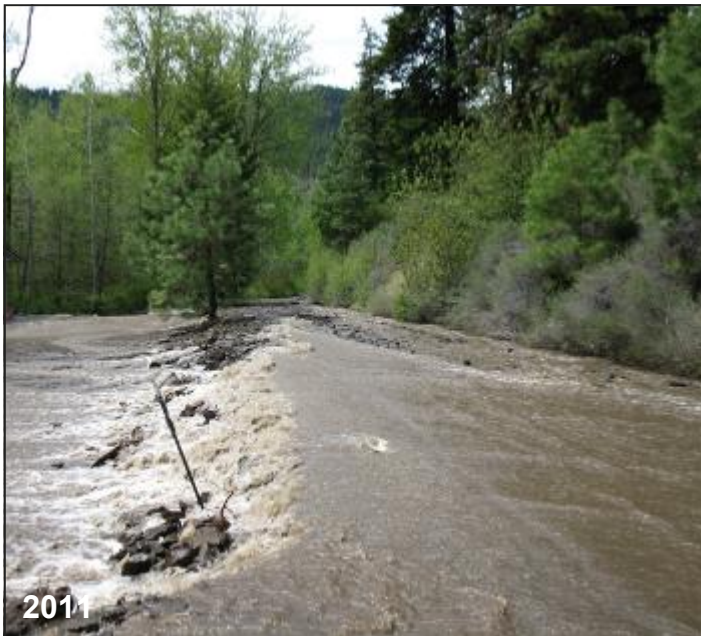
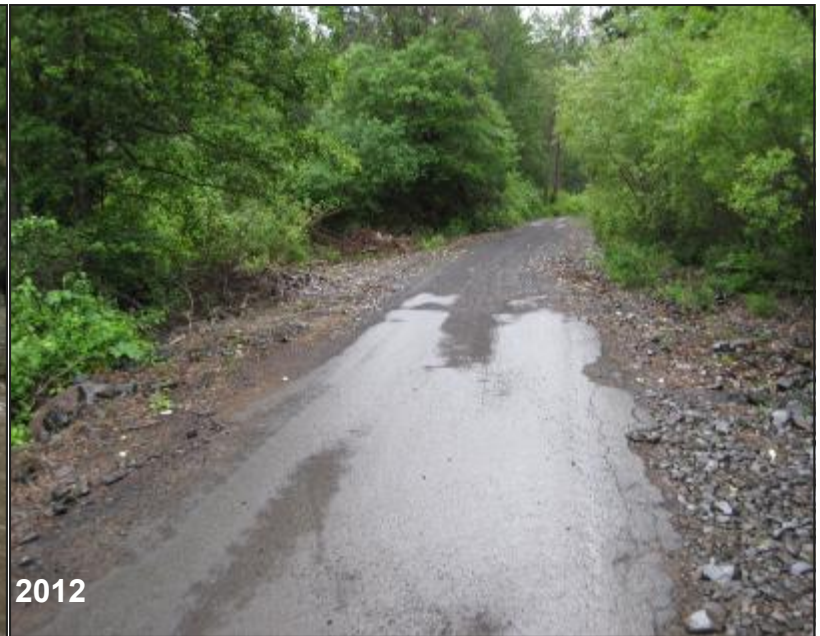
Mile Post 0.0

In May 2011, flood water overtopped multiple culverts, forcing the creek over and down the road. The water moved over the road and damaged the aggregate surface for approximately 2,450 feet. Debris was deposited on the road and in the roadside ditches.

Option A: Clean and repair approximately 1,900 feet of roadway ditch, install 430 feet of rock armor protection on the creek bank, and clear the existing culverts. Road will be resurfaced for approximately 200 feet.

Option B: Stabilize the crossings and relinquish the road easement. Permanently close FSR 1702 beyond mile post 1.

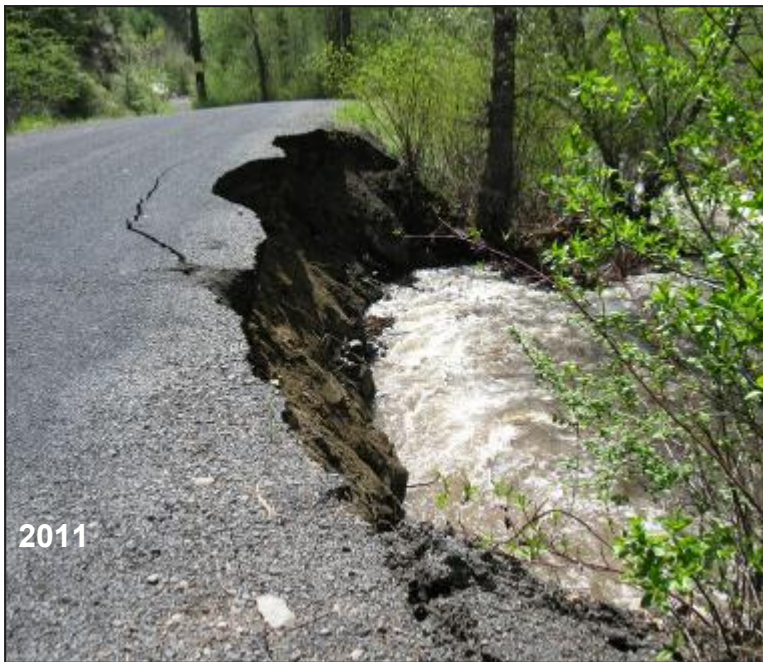
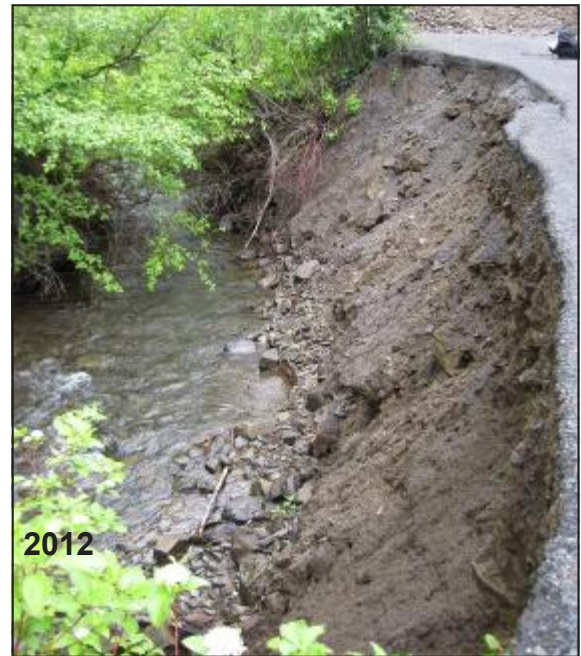
Mile Post 1.0

In the 2011 flood, high water flows eroded and damaged the road, road fill, and road shoulder. Rock creek narrows at this point in the valley with higher velocity flows. On the other side of the road is a steep slope.

Option A: Build a precast concrete block wall to armor the road shoulder and prevent more erosion. Stabilize the area around the road.

Option B: Stabilize the road and bank and relinquish the road easement. Permanently close FSR 1702 beyond mile post 1.

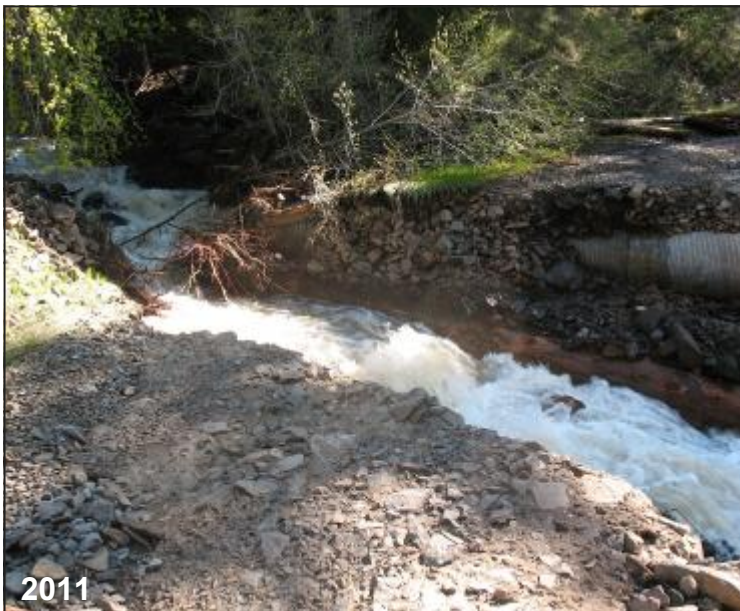
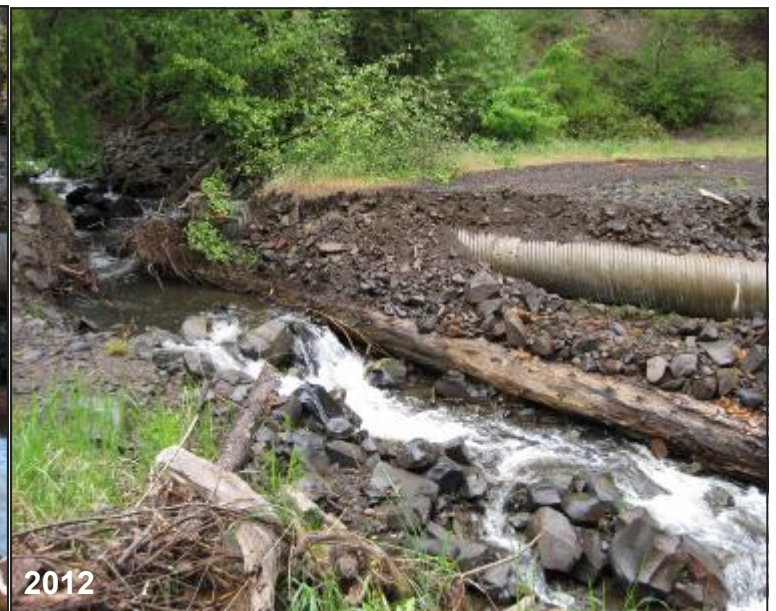
Mile Post 0.2

During the May 2011 flood, debris plugged the culvert and washed out 30 feet of road. There is currently no crossing and the 36 inch culvert is partially exposed.

Option A: Clear and repair roadway and ditches. Install a 60 inch culvert to replace the 36 inch culvert. The crossing would be at the same location.

Option B: Reduce road to maintenance level 1 (closed) and stabilize the crossing. Remove the old culvert and road fill that could potentially be washed downstream.

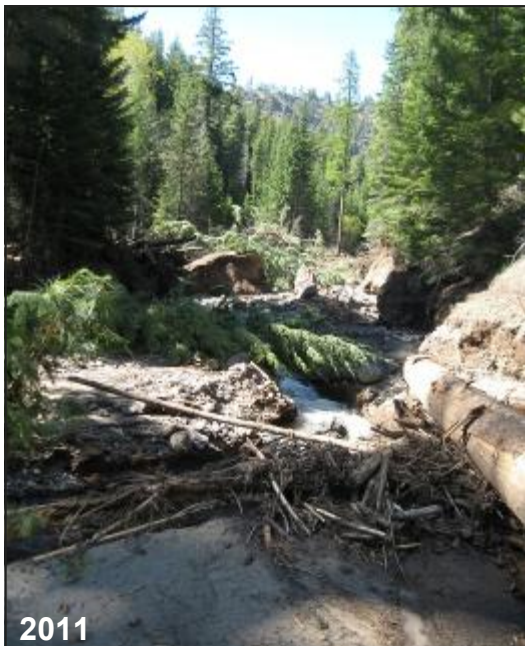
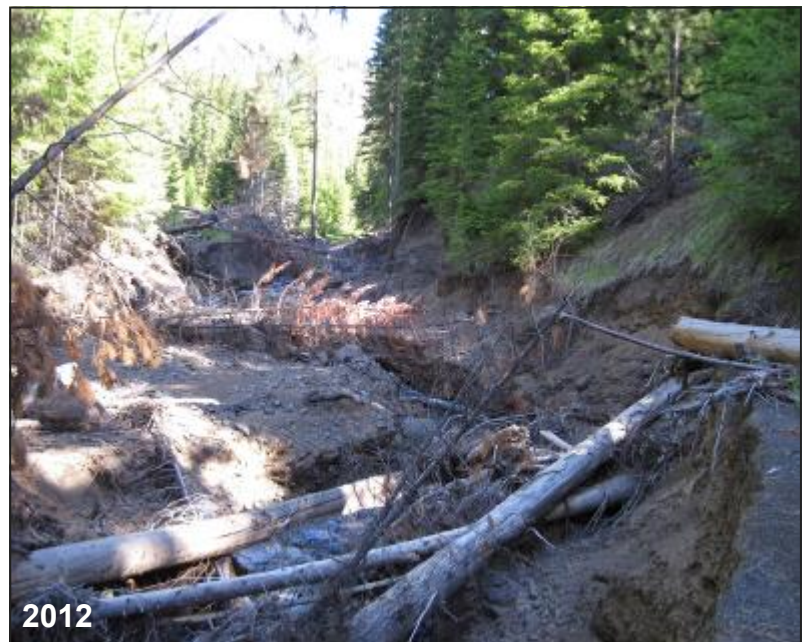
Mile Post 2.0

Gold Creek washed out approximately 300 feet of road way. Above is the space where the road has washed away and where debris and boulders have filled in. During the 2011 flood event, the 60 inch culvert filled with rocks and debris and allowed the stream to overtop the road. The washout changed the course of the stream channel and created a large log jam that is causing river head-cutting.

Option A: Rebuild the road in the same location allowing the stream to reclaim the old channel. The new crossing structure would be a 25 foot bottomless arch at the previous location of the culvert.

Option B: Reduce road to maintenance level 1 (closed) at crossing. Stabilize crossing and remove road and roadway fill that could erode further.

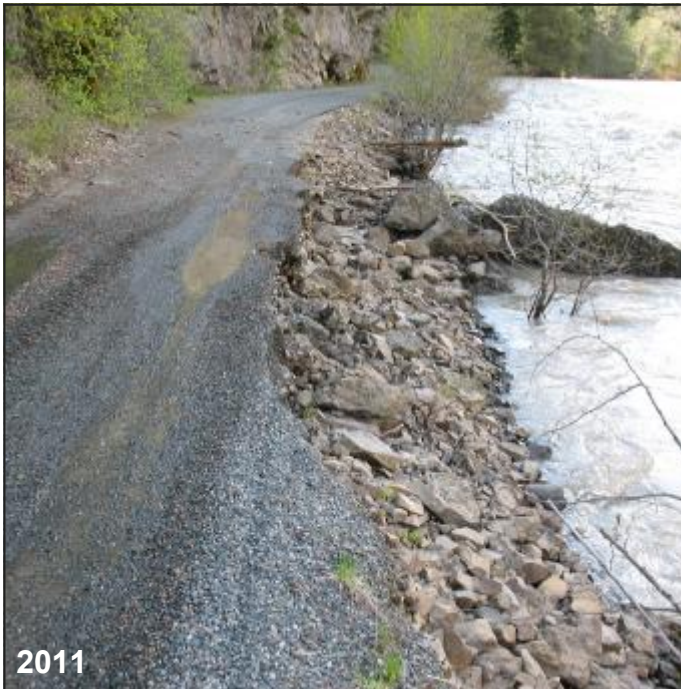
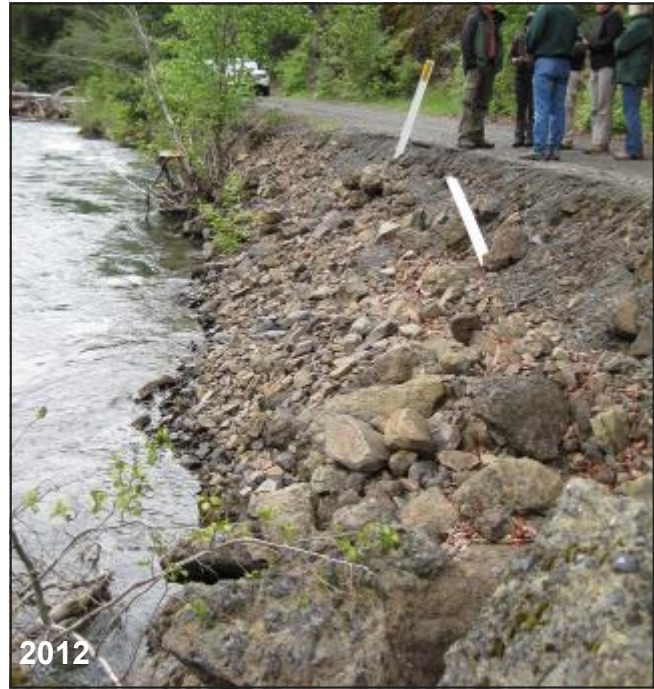
Mile Post 1.3

During the 2011 flood, high flows eroded the bank, road shoulder, and roadway. There is approximately 90 feet of damage resulting in a slumped road shoulder and roadway with a reduced width. At this site, the road is confined between the Naches River and a vertical rock face.

Option A: Reconstruct eroded portion of road armoring river interface with extensive large rock and woody debris. Reconstruct road surface to minimize sedimentation into the river.

Option B: Close 1,500 to 2,000 feet of the road allowing for a turn around area on each side. Remove two thirds of the roadway to prevent additional erosion. Keep some surfacing to assist in stability.

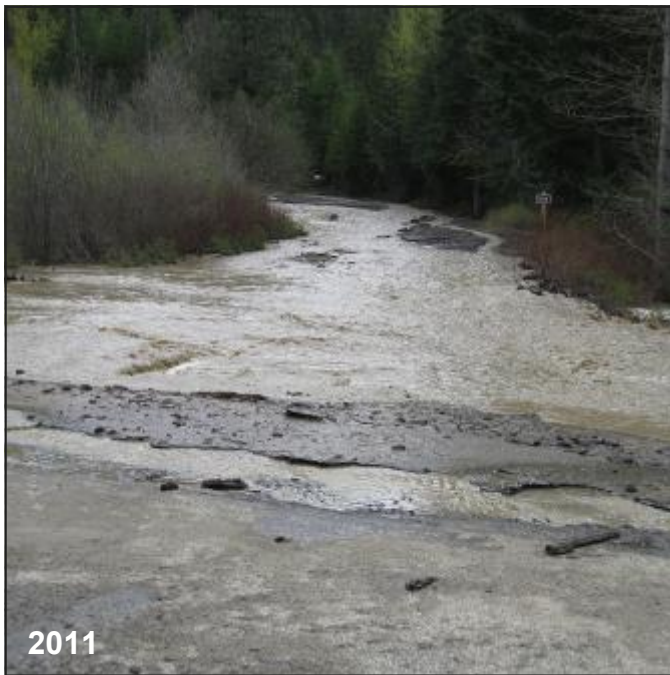
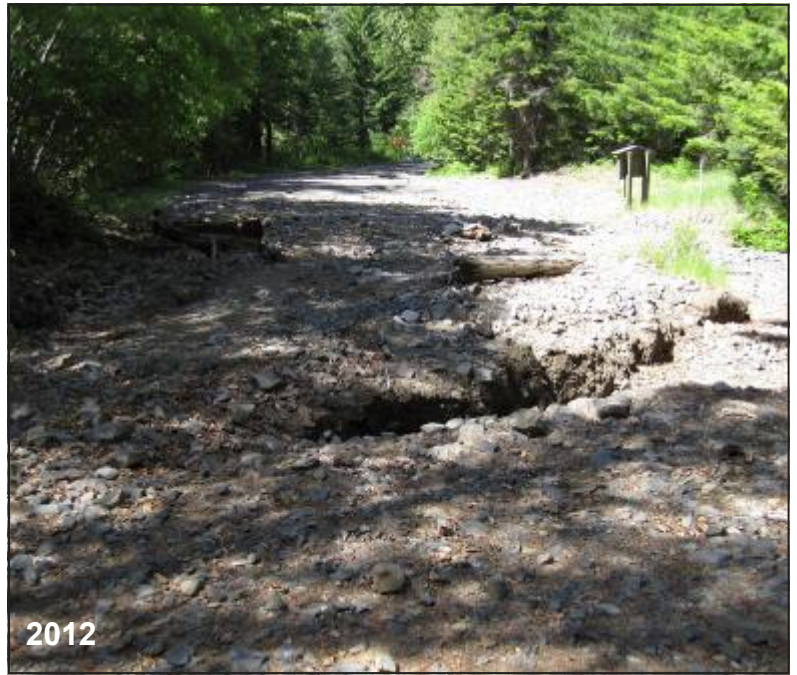
Mile Post 0.0

In 2011, the culvert at the Milk Creek crossing filled and allowed water to overflow onto the road and down towards Highway 410. Approximately 1,700 feet of road surfacing was damaged below the failed crossing. The 72 inch culvert is still in place.

Option A: Pull out wood and debris that is partially blocking the pipe. Repair washed out portions of the road surface with aggregate surfacing.

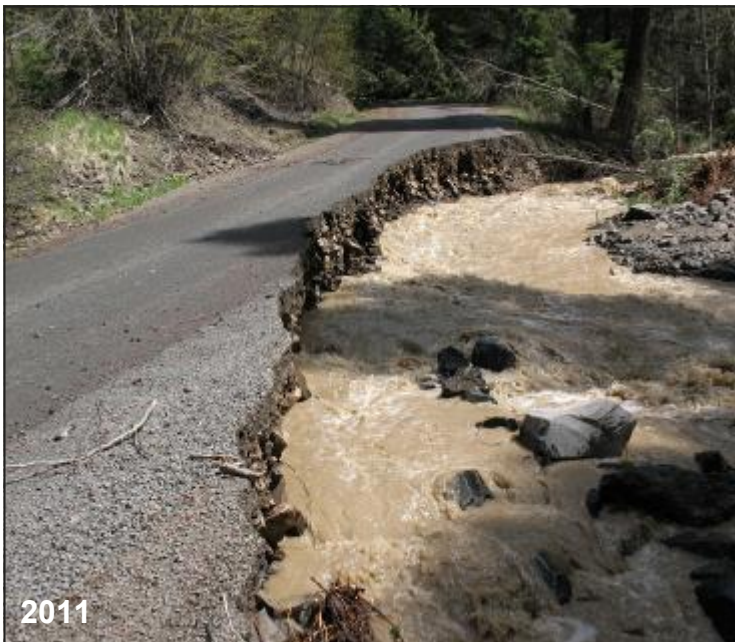
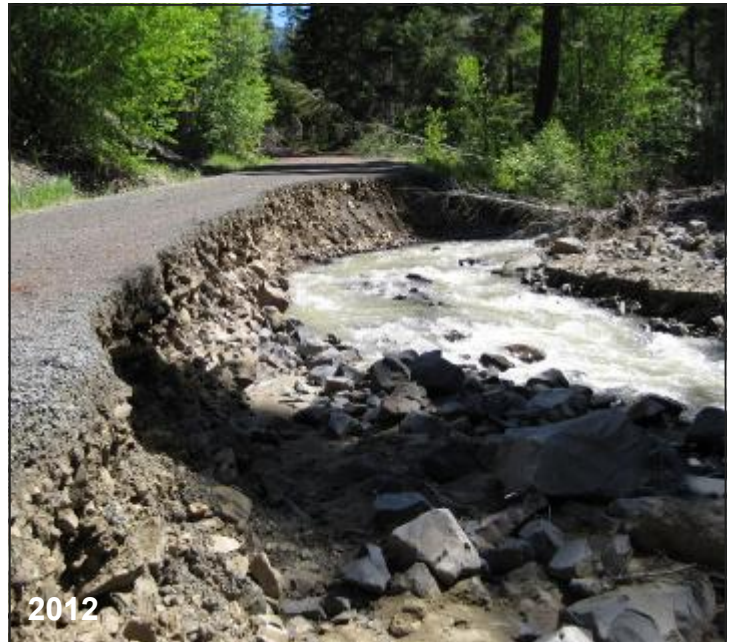
Mile Post 0.6

During the 2011 flood, high flows eroded the road shoulder and bank. Portions of the road shoulder and road way were washed away narrowing the width of the road.

Option A: Re-align the road to go up through the adjacent spur road. The spur road goes to a near-by rock pit and connects back to FSR 1708 at mile post 0.8. The re-aligned road would be made to level three maintenance road standards. The existing road would be decommissioned and the slope would be armored to prevent excess erosion.

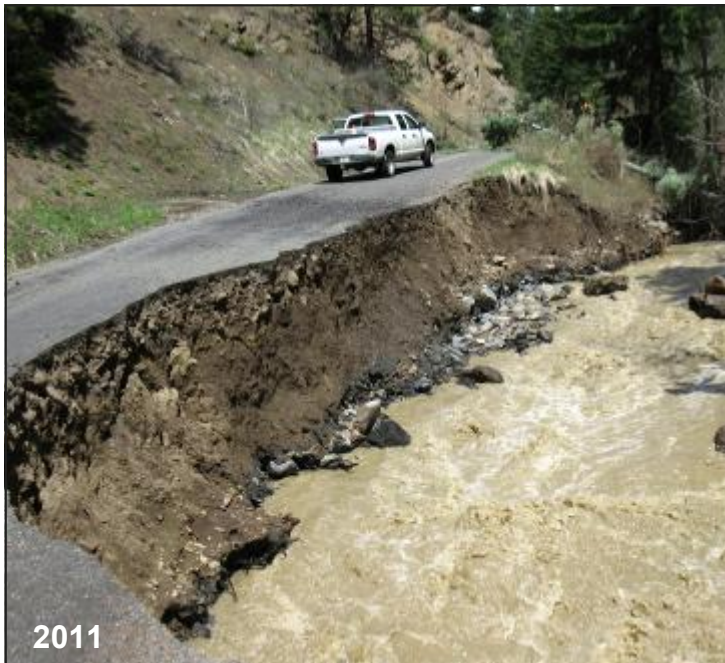
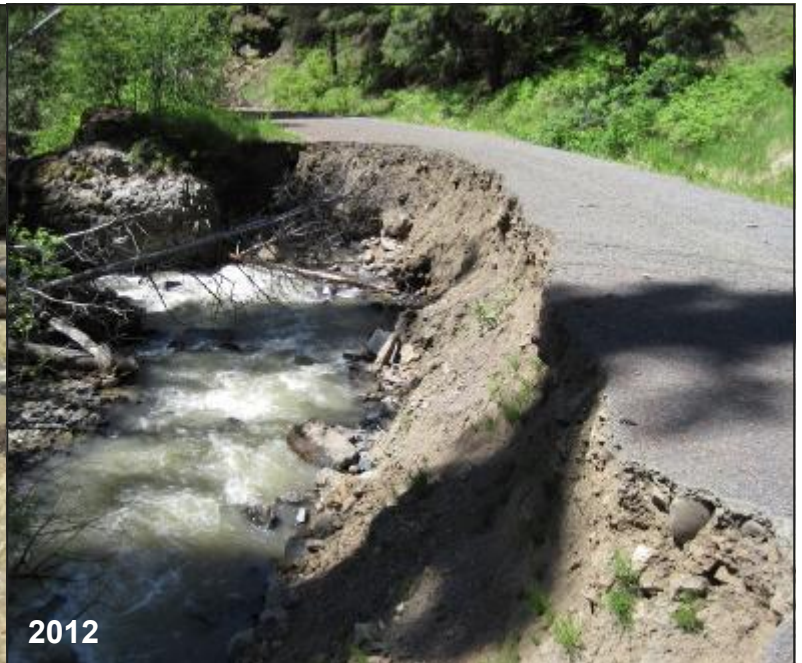
Mile Post 0.8

During the 2011 flood, high flows and debris eroded the road shoulder and bank. Portions of the road shoulder and road way were washed away narrowing the width of the road.

Option A: Re-align the road to go up through the adjacent spur road. The spur road goes to a near-by rock pit and connects back to FSR 1708 at mile post 0.6. The re-aligned road would be made to level three maintenance road standards. The existing road would be decommissioned and the slope would be armored to prevent excess erosion.

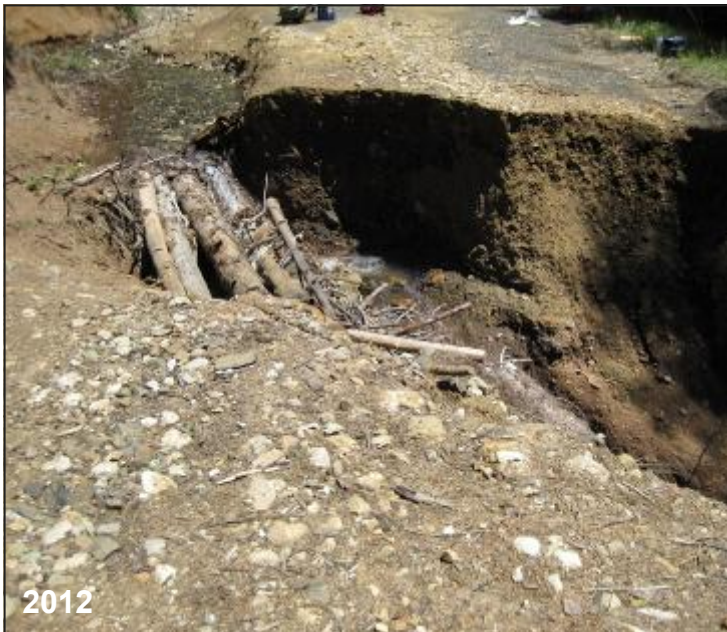
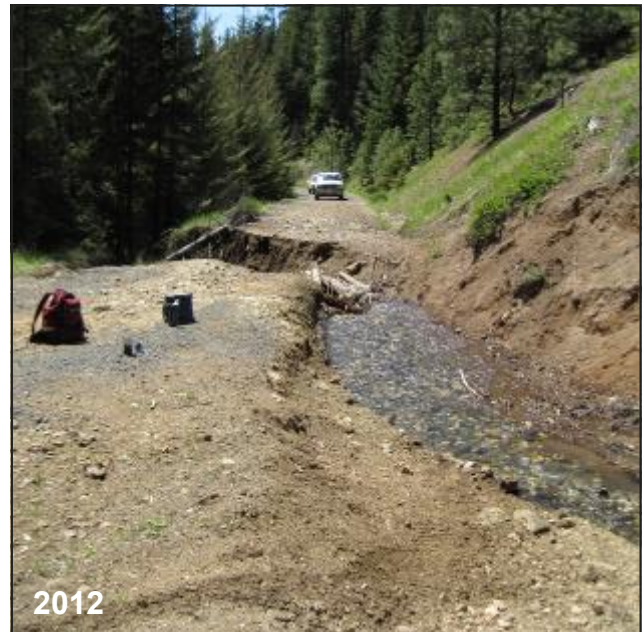
Mile Post 3.9

The creek crossing the road is a tributary to Milk Creek and is in an area with high sediment dispersal. During 2011, the culvert plugged with debris and created a new crossing down the ditch and then over the road.

Option A: Remove the existing buried culvert and replace it with a larger culvert (approximately 60 inches) in the same location. Repair the road and road shoulder and return the stream to the pre-flood channel. Road and ditch would be armored for protection from future flood events.

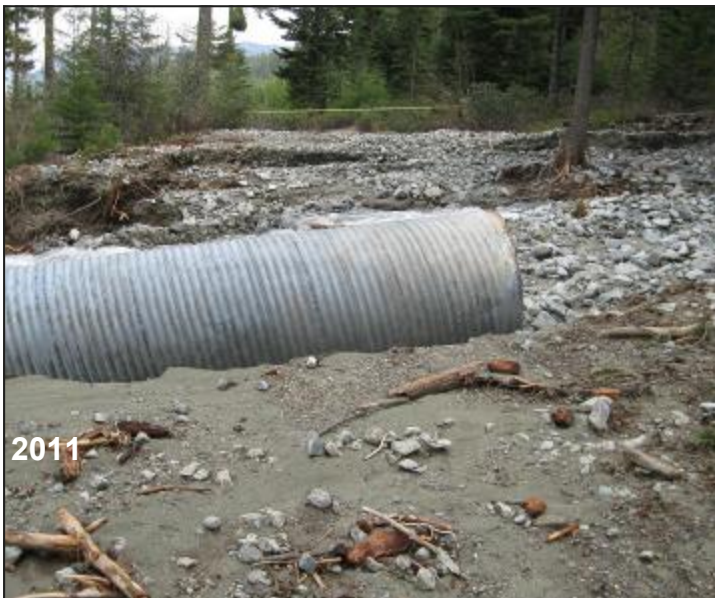
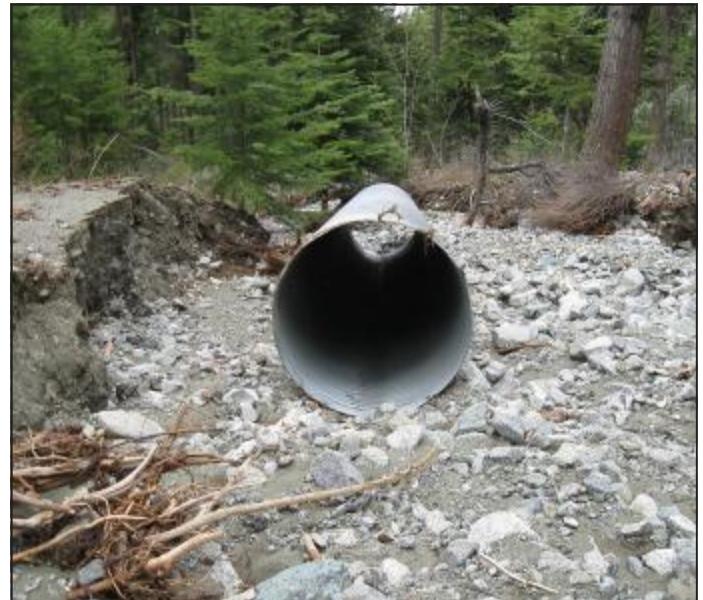
Mile Post 1.6

The damaged crossing is at the location of a stream alluvial fan. During the 2011 flood, high flows and debris washed away the road around the existing culvert and deposited debris all over the site.

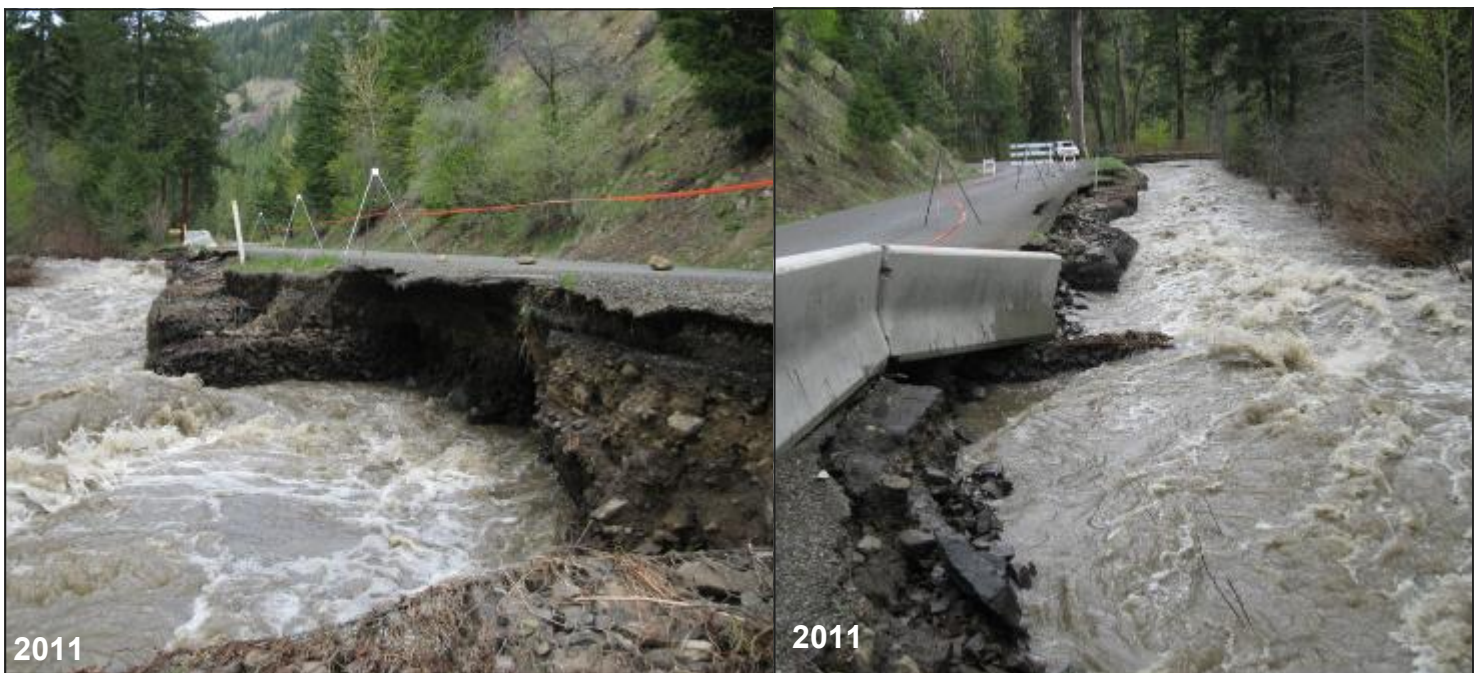
During the 2011 flood, the gabion baskets and bank failed to protect the road and the road collapsed into the stream. Portions of the roadway and road shoulder are missing and the road width is narrowed. Currently, the stream is confined on the road and the campground side at this location.

Option A: Replace failed gabion baskets with a pre-cast concrete block wall. Remove the berm between the stream and the campground, allowing the river to regain that portion of the floodplain. The historic structures of the campground will be protected, however, the picnic area and two campground locations will become part of the river flood plain. These sites are closest to the stream bank. The road would be repaired to pre-flood conditions.

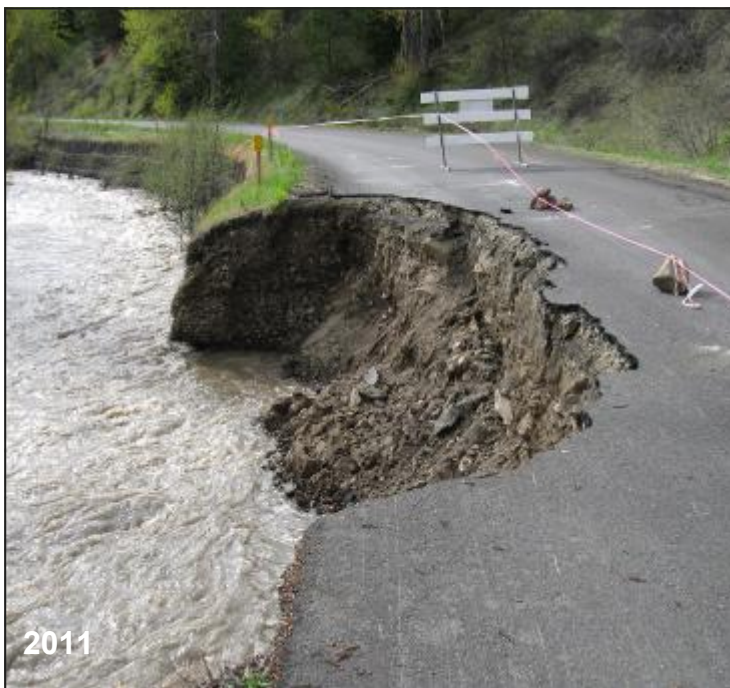
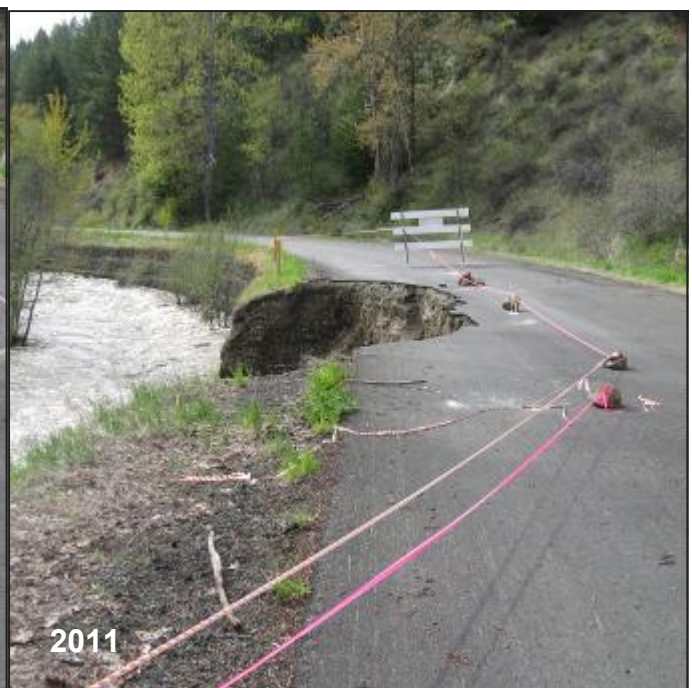
During the 2011 flood, the gabion baskets and bank failed to protect the road and the road collapsed into the stream. Portions of the roadway and road shoulder are missing and the road width is narrowed.

Option A: Replace gabion baskets with a sheet pile wall.

The wall would be made of connecting sheet piles that lock together and would be approximately 120 feet in length. Repair the road to pre-flood condition.
